Risk in Civil Engineering : from natural to man-made hazards

Pierre Delage
Ecole Nationale des ponts et Chaussées¹, Paris

*France-Stanford Conference on “Risk issues in contemporary science and engineering”,
Stanford, 4-6 April 2003*

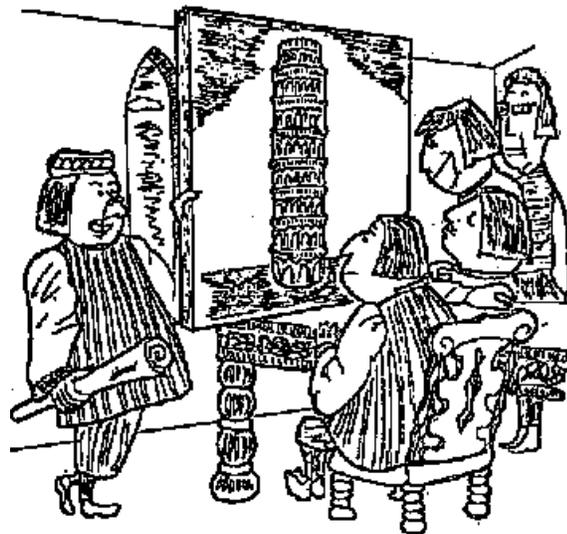
Figure 2 : On the foundations of the Tower of Pisa (and we can save 700 lira by not taking soil tests)

- It is difficult to completely identify the exact nature and properties of the ground on which structures are built. As other materials, soil and rocks have maximum admissible resistance and may fail if higher forces are applied. They are also variable in nature, and even slight changes in their properties between two points may have significant consequences on the stability of the structure (see Figure 2 on the Tower of Pisa)

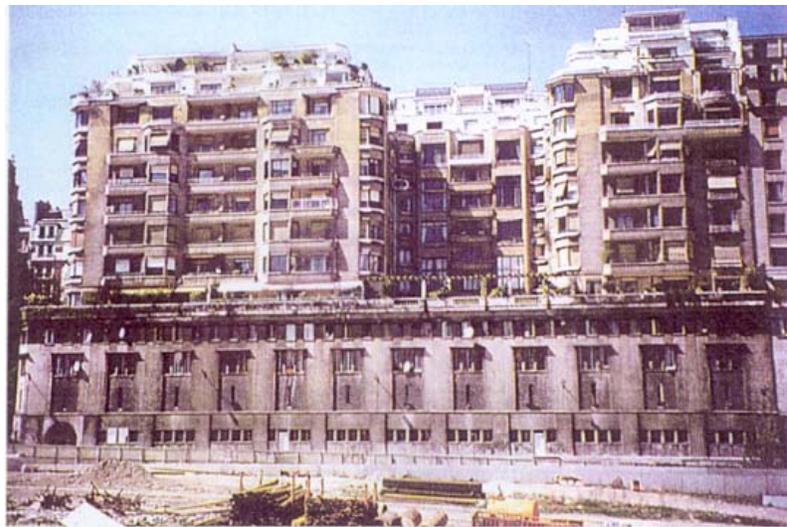
Figure 9 : a view of an unstable building in Paris (Lavisse & Mazaré 1999)

A recent case study concerning geotechnical risk is now briefly commented. Figure 9 (Lavisse & Mazaré 1999) corresponds to a recent serious litigation that occurred in a nice neighbourhood of Paris (Colline de Passy near the river Seine, 16^e arrondissement) where the pressure corresponding to real estate development is significant. Some trouble occurred in the building seen in the photo (8 levels, built in 1930) after a 6 m deep excavation was made below and close to the building, in order to construct a new building. Beside technical considerations, it should be mentioned that the new building would condemn the nice view on the river Seine of the existing building, that was also occupied by socially influent persons including various politicians, journalists and lawyers. Actually, the litigation is still going on and very few information is presently available.

It was observed that the anchored retaining wall had a 10 cm horizontal front displacement, resulting in vertical and horizontal movements of 5-6 cm that severely fissured the existing building (various cm). Of course, construction was immediately stopped and some soil was backfilled against the wall to reduce displacement.

Extensive in-situ soil investigation conducted afterwards (too late !) showed that the foundation of the old building was not satisfactory at all. The building was based on shallow foundations on a very heterogeneous ground formed on one side by the remaining a calcareous cliff and on the other side on weak slope talus coming from the degradation of the calcareous cliff. The Figure shows one of the hypothesis proposed, i.e. the development of a circular instability that explain the trouble. Other possibilities have been proposed by experts. The total cost of the trouble was approximately 75 billion dollars, and Justice had to distribute the cost in proportion of the estimated responsibility to the various organisations involved : owner, construction company, geotechnical consulting firms. In spite of the obvious deficient nature of the foundation of the existing building, the responsibility of the construction company was engaged, resulting in a significant loss of money.
